CASE STUDY

Cable and Wireless, London

Client:	Cable and Wireless
Project Manager:	Sub Contractor - Bakers Environmental
Location:	-
Project Value:	£2,000
Project Type:	Tank and Bund Lining
Project Scope:	-

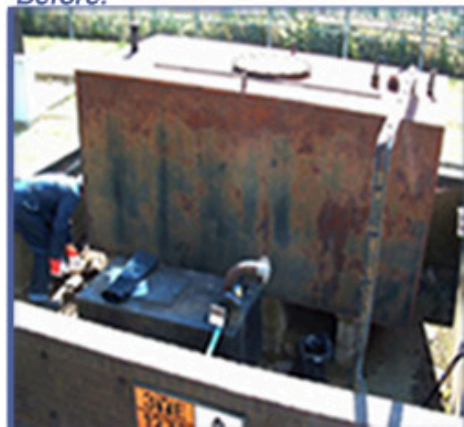
Before:

The existing floor of a gas oil bund had broken down and the walls showed signs of deterioration and would need to be reinforced. The bund was obviously leaking and under the Oil Storage Guidelines this problem would have to be rectified. The storage tanks themselves were rusting and pitted and would require a tank lining system to extend their life expectancy.
